Building and Environment

Field study of NO_x degradation by a mineral-based air purifying paint

Q.L. Yu*, Y. Hendrix, S. Lorencik, H.J.H. Brouwers

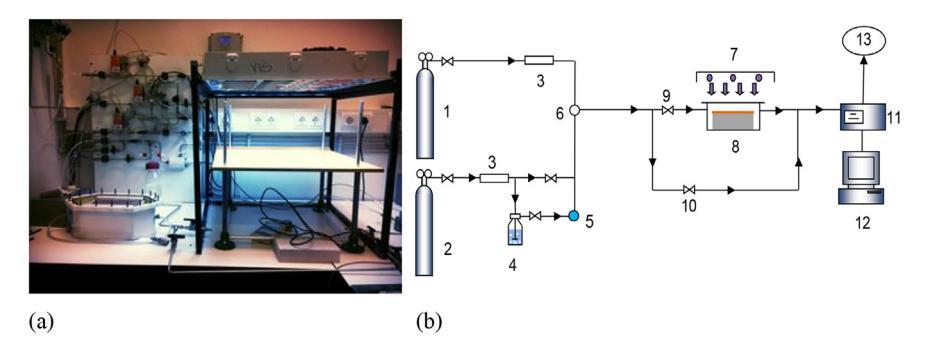
Fig. 1. (a) Picture of the photocatalytic set-up (b) schematic overview of the PCO test (1. NO gas supply; 2. Synthetic air; 3. Mass controller meter; 4. Humidifier; 5. Humidity controller; 6. Temperature and relative humidity sensor; 7. Light source; 8. Reactor; 9–10. Valves; 11. NOx analyzer; 12. Computer; 13. Vent).

The air pollutant removal activity of the photocatalytic paint was firstly assessed under fully controlled laboratory conditions, following the ISO 22197-1 [34]. A custom-made plug-flow experimental set-up was used with nitrogen oxide as the model pollutant. The picture of the setup is shown in Fig. 1a, including the light source, environmental parameters control panel, gas source and the reactor. Panels with a surface size of 200 mm \times 100 mm were first coated with the mineral based air purifying paint, applying the lime render and/or polycarbonate as the substrate. Subsequently, the samples were irradiated by UVA light for 5 h, then washed by demi-water for 2 h and finally oven dried. The following testing conditions were applied: 10 W/m^2 of UVA irradiance, 50% of relative humidity, 3 L/min of flow rate, 1 ppm of NO inlet concentration. The exposure testing sample surface was $200 \text{ mm} \times 100 \text{ mm}$ with the reactor height of 3 mm, namely the distance between the reactor cover and the surface of the testing sample. The duration of the measurements was set to 1 h under irradiation. Prior to irradiating the sample with UVA light, the system was conditioned until a constant NO concentration was acquired, to reach NO adsorption saturation on the surface of the testing sample. A schematic overview of the PCO experiment is shown in Fig. 1b.

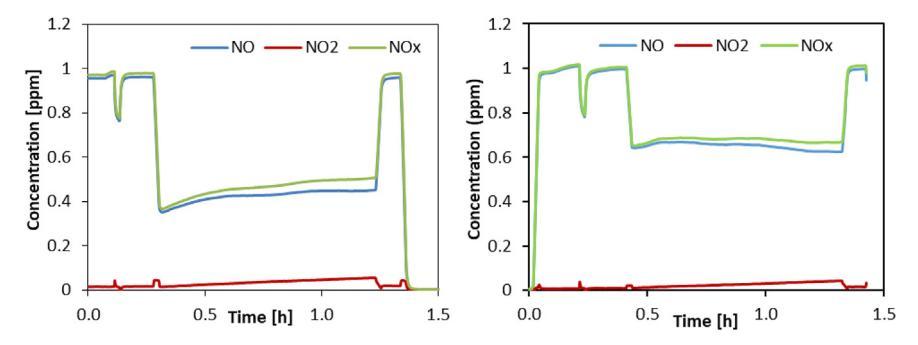
Fig. 2. Results of the lab test following ISO standard. On the left is the lime render panel and on the right is the polycarbonate panel.

The results of these tests are shown in Fig. 2. The NO_x removal efficiency of the lime render panel is 48.2% and the efficiency of the polycarbonate panel is 34.2%. The higher efficiency of the lime render panel can be attributed to the rougher surface which results in more available photocatalytically active sites. Furthermore, it should be noted that the generation of NO_2 during the experiments is very low, confirming again the excellent air pollutant removal ability. It is suggested in Ref. [29] that a NO_x removal of 45% can be achieved under ideal weather conditions with a paving stone that has a NO_x removal of 38% under ISO 22197-2 condition. Therefore, a decent air purifying performance applying the present photocatalytic paint can be expected under outdoor conditions.

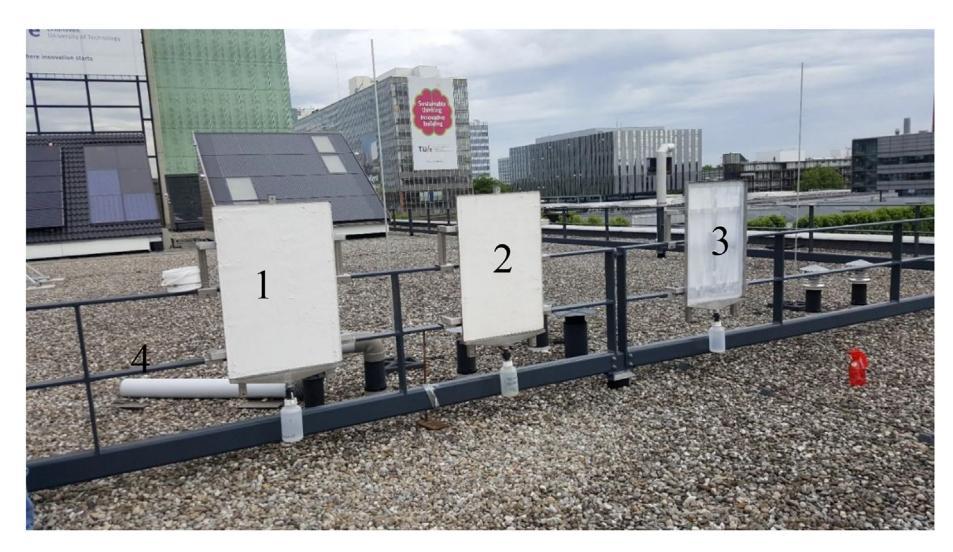
Fig. 4. The setup of the panels outside on the roof of the Vertigo building, Eindhoven. 1: PCO lime render panel, 2: Reference panel, 3: PCO polycarbonate panel, 4: air tube connected to NOx analyzer.

The setup of the outdoor monitoring is shown in Fig. 4. Two panels of $100 \,\mathrm{cm} \times 65 \,\mathrm{cm}$ were prepared with lime render (No. 1 and 2 in Fig. 4) and one panel with polycarbonate (No. 3 in Fig. 4). The panels No. 1 and No. 3 in Fig. 4 were then coated with the mineral based transparent photocatalytic paint, and mounted to a back support. The other panel of lime render (No. 2 in Fig. 4) was coated with only the base of this transparent paint (i.e. without photocatalyst) and was used as a reference panel. The panels were fixed to the handrail of the roof, about 60 cm from the roof, facing to the south. Rain water reaching the surface of the panels was collected by a 2L bottle hanging beneath the panels. The water in the bottles was collected weekly and the panels were washed with distilled water to reset the amount of ions on the panels. In case of heavy rains, the collection frequency was adjusted in order to avoid possible water loss due to overflowing. The adopted artificial washing procedure was to make sure each week's measurement only measured the ions collected by the panels in that week and not from the previous weeks.

The NO_x concentrations at the location next to the panels were measured continuously using an online HORIBA 370 NO_x analyzer (see the sampling point, labelled with No. 4 in Fig. 4). The NO_x analyzer measures the NO and NO₂ concentration every 5 s. Besides the NO_x collection from the own analyzer, NO and NO₂ data were also taken from public institute of people's health and environment (RIVM, The Netherlands) [43] (see Fig. 8). These data were measured at the Genovevelaan Street in Eindhoven (about 4 km from the monitoring site in the present study).

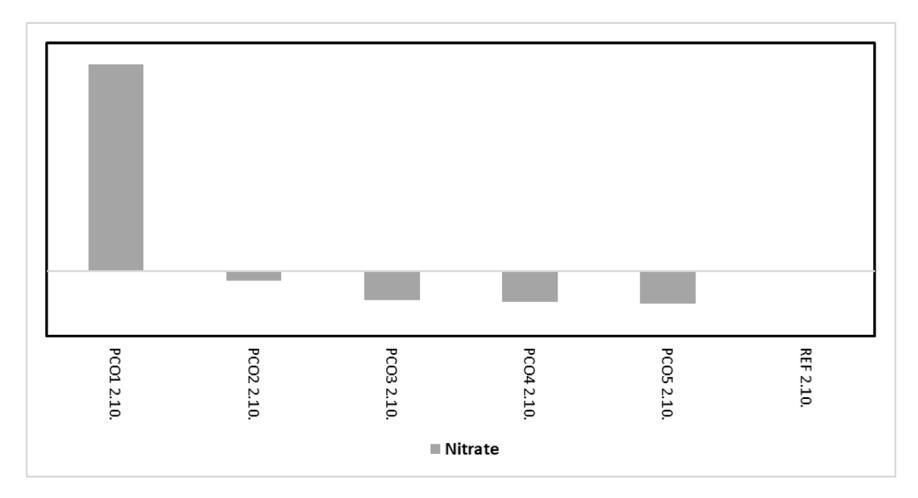
Fig. 5. The washing efficiency test on the measurement on 2.10.2015.

The ion masses of these washings were compared to the reference panel. Figs. 5 and 6 show the washing efficiency results based on two dates (2.10.2015 and 9.10.2015).

The results show that two sets of washing is relatively sufficient to wash most of the ions adsorbed on the surface of the PCO panel. This was obvious in case of sample washed on 2.10.2015. Three sets of washing were required on 9.10.2015 in order to get to the same level as on REF panel. Therefore, 4 sets of washing were eventually applied in order to wash both panels effectively throughout the whole monitoring period.

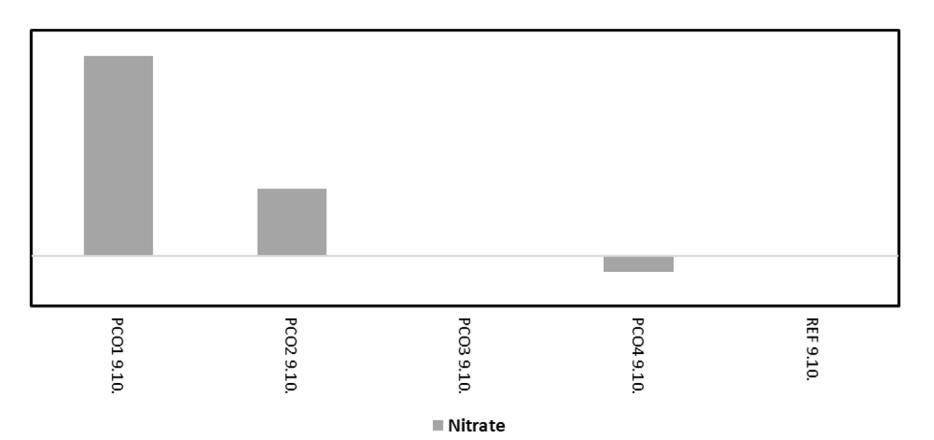
Fig. 6. The washing efficiency test on the measurement on 9.10.2015.

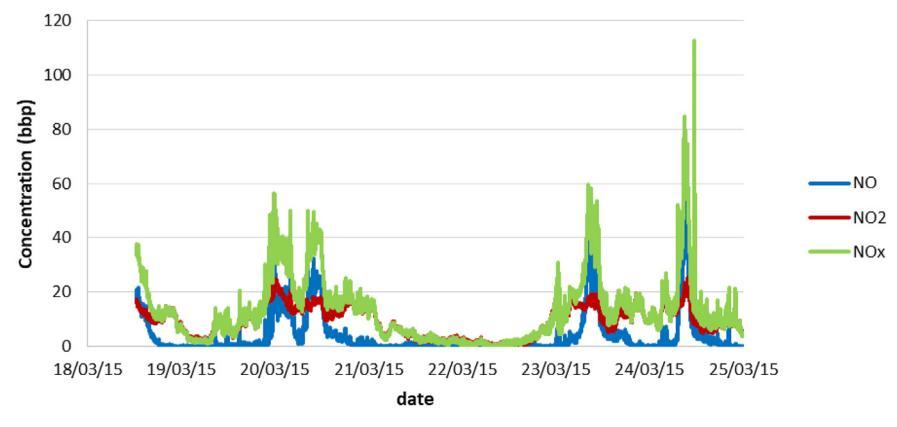
Fig. 7. The NO_x concentration collected on one week (18–25 March 2015).

A pre-air quality monitoring was performed between March 2015 and May 2015 before the commencement of the real monitoring campaign on the performance of the photocatalytic paint. The aim was to check the robustness and stability of the monitoring system. Furthermore, the analysis was performed in order to evaluate the suitability of the environment for the analysis of photocatalytic efficiency of panels coated with the developed photocatalytic mineral paint. Some typical results, selected one week in March, are shown in Fig. 7.

These data show that the NO_x concentration varies significantly during the day. Although in the peak hours, the concentration reached up to 115 ppb, this high concentration is very exceptional. Nevertheless, it can be seen that in most of the time the NO concentration is below 20 ppb. The measured NO_2 concentrations are in most of the time higher than NO, as expected. But in peak values, it is clearly seen that NO concentration is higher, indicating the direct effect of car emissions. Furthermore, it can be seen that although the day-today NOx concentration values measured at the monitoring site are different from the values taken from RIVM, the trend as well as the range of the measured pollutants are very similar. This confirms the reliability of the site monitoring.

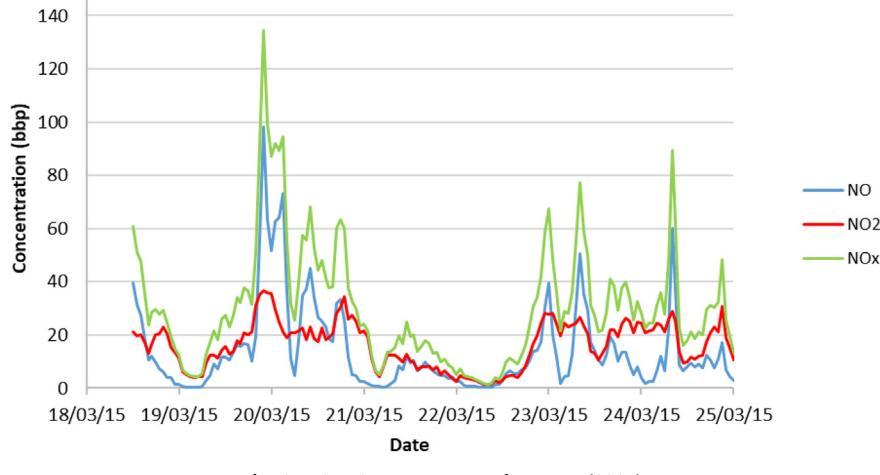
Fig. 8. NO/NO₂ measurement by RVIM (2015).

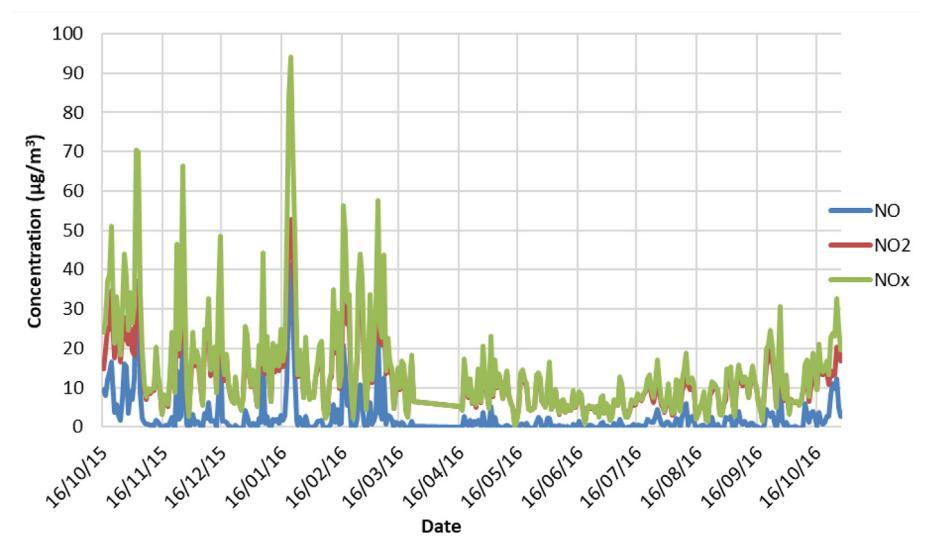
Fig. 9. Average values of NO, NO₂ and NO_x measured on each days between 16 and 10-2015 and 28-10-2016.

The collected NO_x concentration data are shown in Figs. 9 and 10, where Fig. 9 shows the average values of every single day and Fig. 10 shows the highest values of every single day. A clear difference in concentration between the two figures can be observed, which shows that the NO_x concentration can increase for short times. The EU goal is to have, on average, not more than $40 \,\mu g/m^3 \, NO_2$ (annual mean) and not more than 18 h per year in which the concentration is $200 \,\mu g/m^3$ or more [44]. It was calculated that over the year only for 4.2 h the $200 \,\mu g/m^3$ limit was exceeded. In addition, according to Fig. 9, the NO_x concentration on average indeed did not reach $40 \,\mu g/m^3$ in most days. Nevertheless, these low concentrations clarify that the amount of nitrates measured could have been higher if the same test would have been performed in more polluted areas [45].

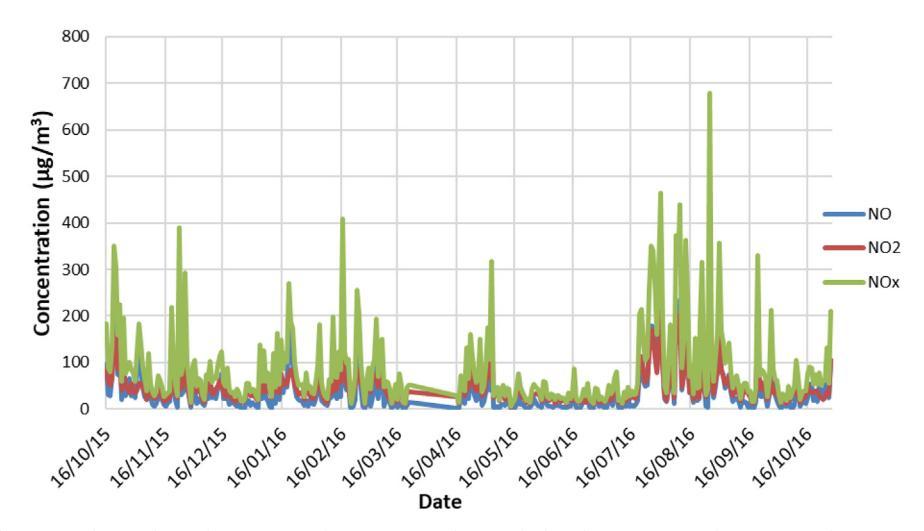
Fig. 10. Highest values of NO, NO_2 and NO_x measured on each days between 16 and 10-2015 and 28-10-2016.

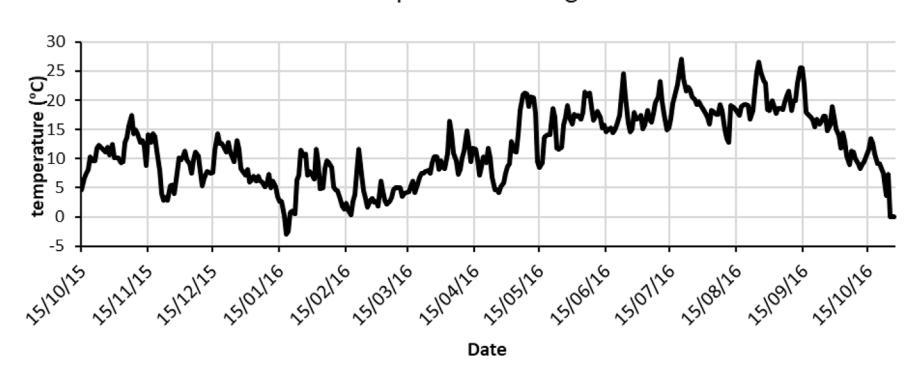
Fig. 11. Average Temperature of each day between 15 and 10-2015 and 27-10-2016.

The data of the weather condition close to the panels were collected and shown in Figs. 11–15. The weather can have a large influence on the PCO reaction [16,46]. The humidity shown in Fig. 14 shows that the average humidity in Eindhoven is almost every day very high. Most of the time the RH is over 60% and often it even reaches over 80%. Such a high humidity level negatively influences the PCO efficiency [47,48]. The wind is relatively strong as the average wind speed is in general higher than 2 m/s, while according to Gallus et al. [31] a wind speed value of 1 m/s would provide good air removal efficiency. In addition to the very high humidity and wind speed, during the autumn and winter, the irradiance was low. In this period, the light intensities are in general lower than 50 W/m², about 20–30 W/m². While according to [49],

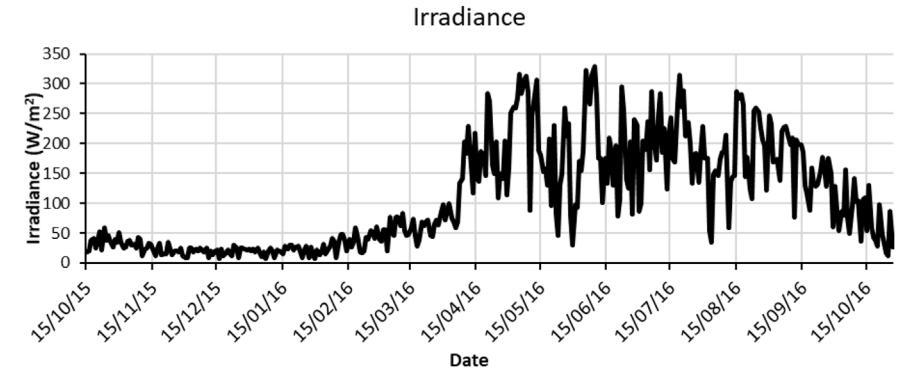
Fig. 12. Average amount of irradiance of each day between 15 and 10-2015 and 27-10-2016.

about 9% of the irradiance of solar radiation outside the atmosphere is UV light, which means a rather low UV light intensities of about 2–3 W/m² in the monitoring site. Folli et al. [45] reported that a UV irradiance value of 6.9 W/m^2 can provide an adequate NO abatement. This indicates that the acquired low UV irradiance value in this research would provide a rather poor photocatalytic effect. In overall, these poor weather conditions would contribute to rather low photocatalytic

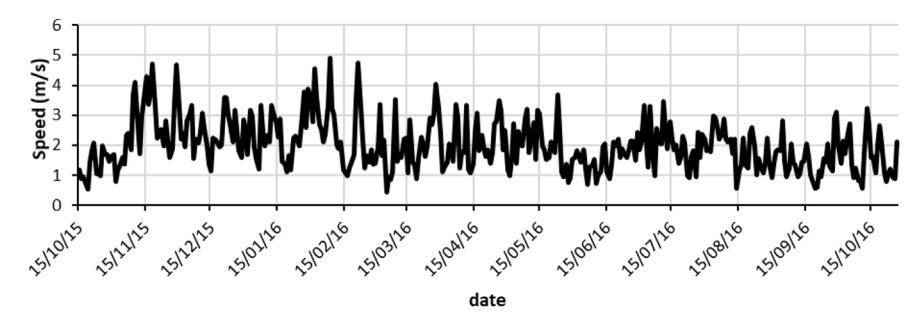
Fig. 13. Average wind speed of each day between 15 and 10-2015 and 27-10-2016.

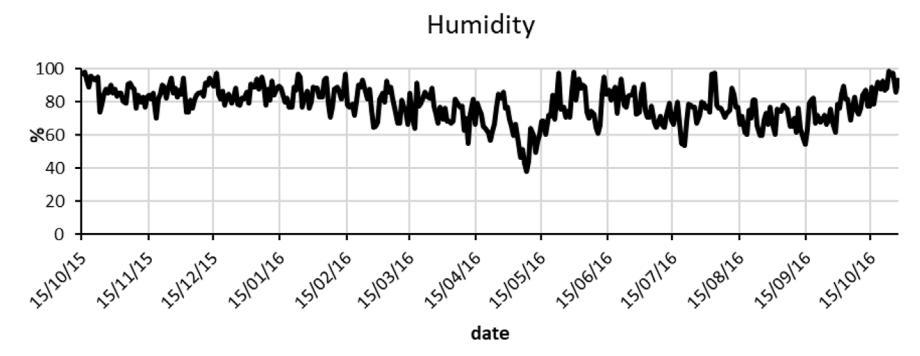
Fig. 14. Average humidity of each day between 15 and 10-2015 and 27-10-2016.

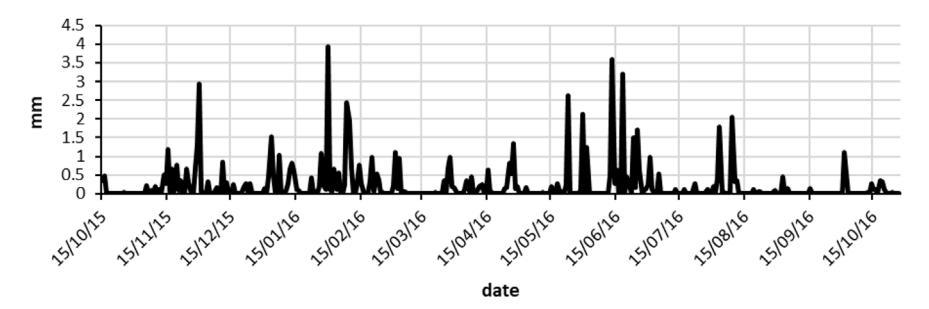
Fig. 15. Precipitation of each day between 15 and 10-2015 and 27-10-2016.

shown here. In addition to the total nitrate amounts, the amount of rain water collected by each panel is also shown since the total amount of ions collected in the rain water immensely depends on these amounts. The photocatalytic activity of the PCO panel with lime render as the substrate is visible for most of the measurements as its nitrate amount exceeds those of the reference panel. Nevertheless, in some weeks, the nitrate amount from the reference panel exceeds that of the PCO lime render panel. For example, in the first week of August 2016, the collected nitrate from the reference panel is obviously more than that from the PCO panel. This can be explained by the weather condition, as can be seen from Fig. 15 that it rained a lot in this week which resulted in very low or almost no photocatalytic effect due to supersaturation of the panels. It was found [30] that it is very hard to reconcile NO abatement entirely with a photocatalytic process under the conditions of little sun and substantial rain. Considerable pollution wash-off by rain is clearly observed in Fig. 16, especially when correlating the collected nitrate by the reference panel with the weather conditions shown in Fig. 15, which is also confirmed by Folli et al. [30].

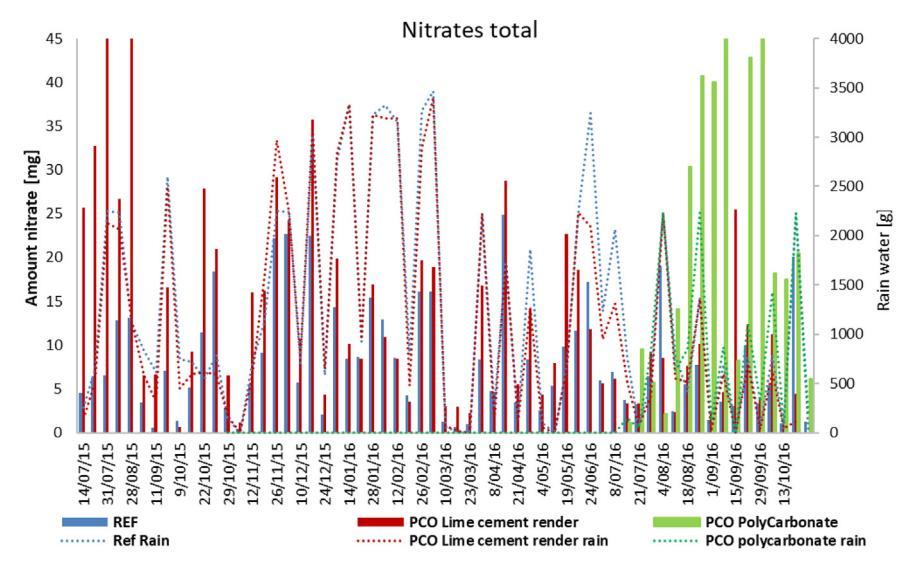
Fig. 16. The amounts of nitrate ions measured in the wash and rain water, and the amount of water collected.

The amount of nitrate ions in the rain water and washing water collected by the panels are presented in Fig. 16. It has to be emphasized that nitrite was also analyzed in the collected water, but the amount was too low to be detectable. Therefore, only the amount of nitrate is

It is also rather obvious that the activity of the PCO lime render panel decreases over the entire monitoring period. Initially the activity was supposed to increase during the summer time of 2016. However, the overall collected data did not show any extra high difference in nitrate amounts, possibly attributed to the high amount raining and deactivation of the photocatalyst. The reason for the deactivation will be further analyzed in the following sections.

The polycarbonate panel (No. 3) was installed at a later stage, in June 2016. It did not show significant differences in nitrate amounts in the first weeks after installation, compared to the reference panel. However, after the first three weeks, the photocatalytic activity started increasing. This can be explained by the time needed for the activation of the photocatalysts which were partly covered by the binder in the mineral paint. The coverage of the photocatalysts causes inhabitation of photocatalytic oxidation of air pollutants. In fact, the nitrate amounts surpass those of the lime render PCO panel. This higher activity indicates as well the deactivation of the PCO lime render panel. The lab scale measurements showed that the lime render panel should have had a higher efficiency (See Section 2) indicating that if there would have been no deactivation, the lime render panel should have had a higher activity. Next to the nitrate amounts also the amount of rain water is higher, which can be explained by the different penetration depths in the panel attributed to the difference in the rendering materials. While this higher amount of rain water can have contributed to the higher nitrate amounts, the increase is too large to be only caused by the amount of rain.

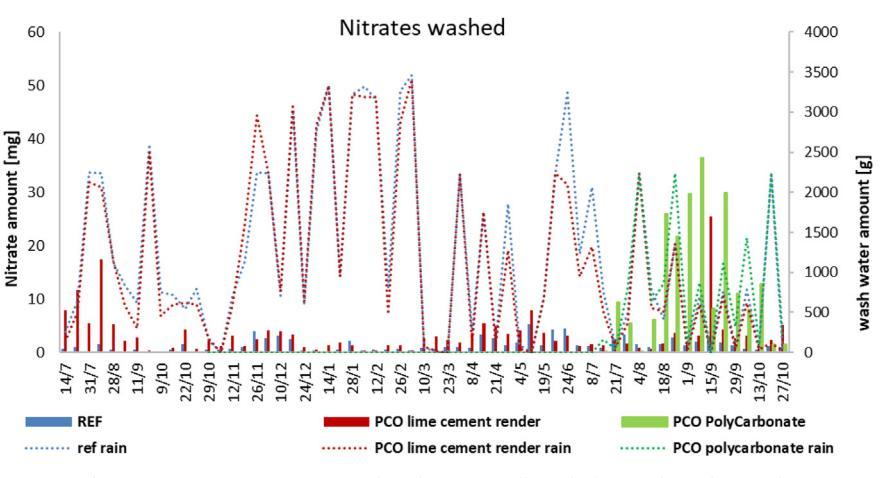
Fig. 17. Nitrate amounts measured in the water collected after washing the panels.

Figs. 17 and 18 show separately the amount of nitrate measured from the water used to wash the panel and the rain water collected by the panels. It can be seen the majority of nitrate is collected by the natural rain flushing and the artificial washing only helps to collect the produced nitrate. This shows that artificial washing can be skipped in the future research applying this principle. As on the other hand, artificial washing does not really contribute much to the collected ions and on the other hand, artificial washing in fact alters the pollutants degradation efficiency because the surface becomes wet after washing which causes inactivation within certain time period.

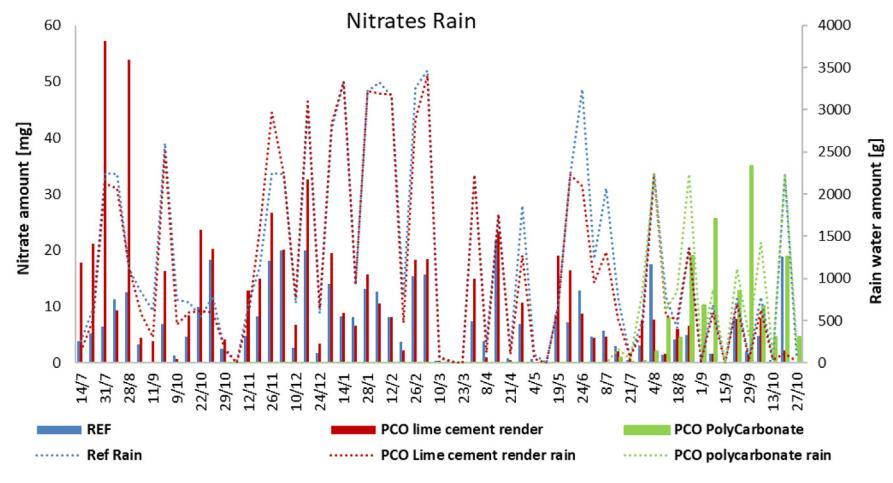
Fig. 18. Nitrate amounts measured in the rain water collected by the panels.

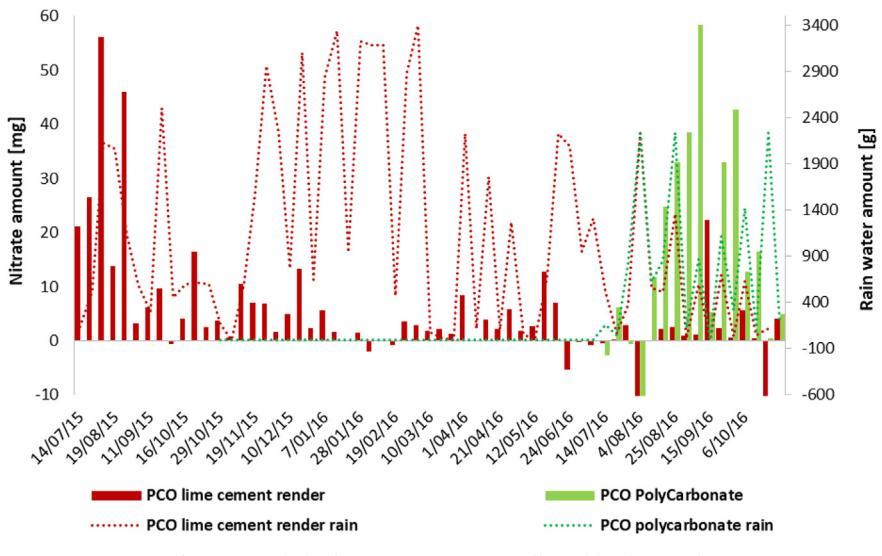
Fig. 19. Total absolute nitrate amounts collected by the panels.

In addition, the absolute amount of the NO₃⁻ that are removed by rain and artificial washing are calculated, by deducting the same amount of nitrate collected by the reference panel and the results are shown in Fig. 19. These figures show very evident the air purification efficiency of this mineral-based transparent coating. It is clear that the degradation efficiency becomes dramatically lower when there is a large quantity of rain water, which causes the competition between water molecular and NO_x molecular [25].

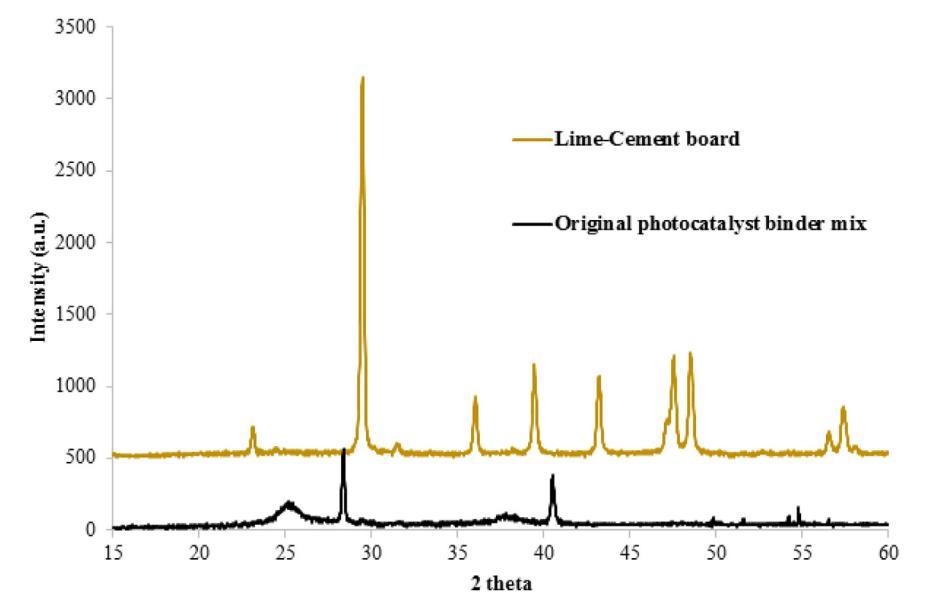
Fig. 20. X-ray diffractions of the aged coating.

The XRD analysis was performed by using a Bruker D8 advance powder X-ray diffractometer with a Cu tube (20 kV, 10 mA) with a scanning range from 5° to 65° (20), applying a step 0.02° and 0.2 s/step measuring time. The qualitative analysis was carried out by using the Diffracplus Software (Bruker AXS) and the PDF database of ICDD. The results are shown in Fig. 20. It is clearly shown that calcite is the primary phase in the tested coating. All major peaks correspond to the calcite crystal structure. Only a very small trace of dolomite (MgCa $(CO_3)_2$) peak can be seen. No detectable TiO₂ is observed, which is in line with the XRF analysis. While in the original photocatalytic paint, also shown in Fig. 20, it can be clearly seen that the broad peaks around 25 and 38 indicate the existence of anatase nanocrystals and the sharp peaks at 28 and 40.5 rutile.

It is surprising to observe that the initially applied photocatalysts were almost entirely disappeared from the XRD and XRF analysis. This can be possibly explained by the following reasons. Firstly, the gradual reaction of lime binder to calcite which over time overgrows the surface of the photocatalyst. Karatasios et al. [51] observed a uniform and
